Fish Response to Restoration in Walker & Lagunitas Creeks

Gregory Andrew, MMWD

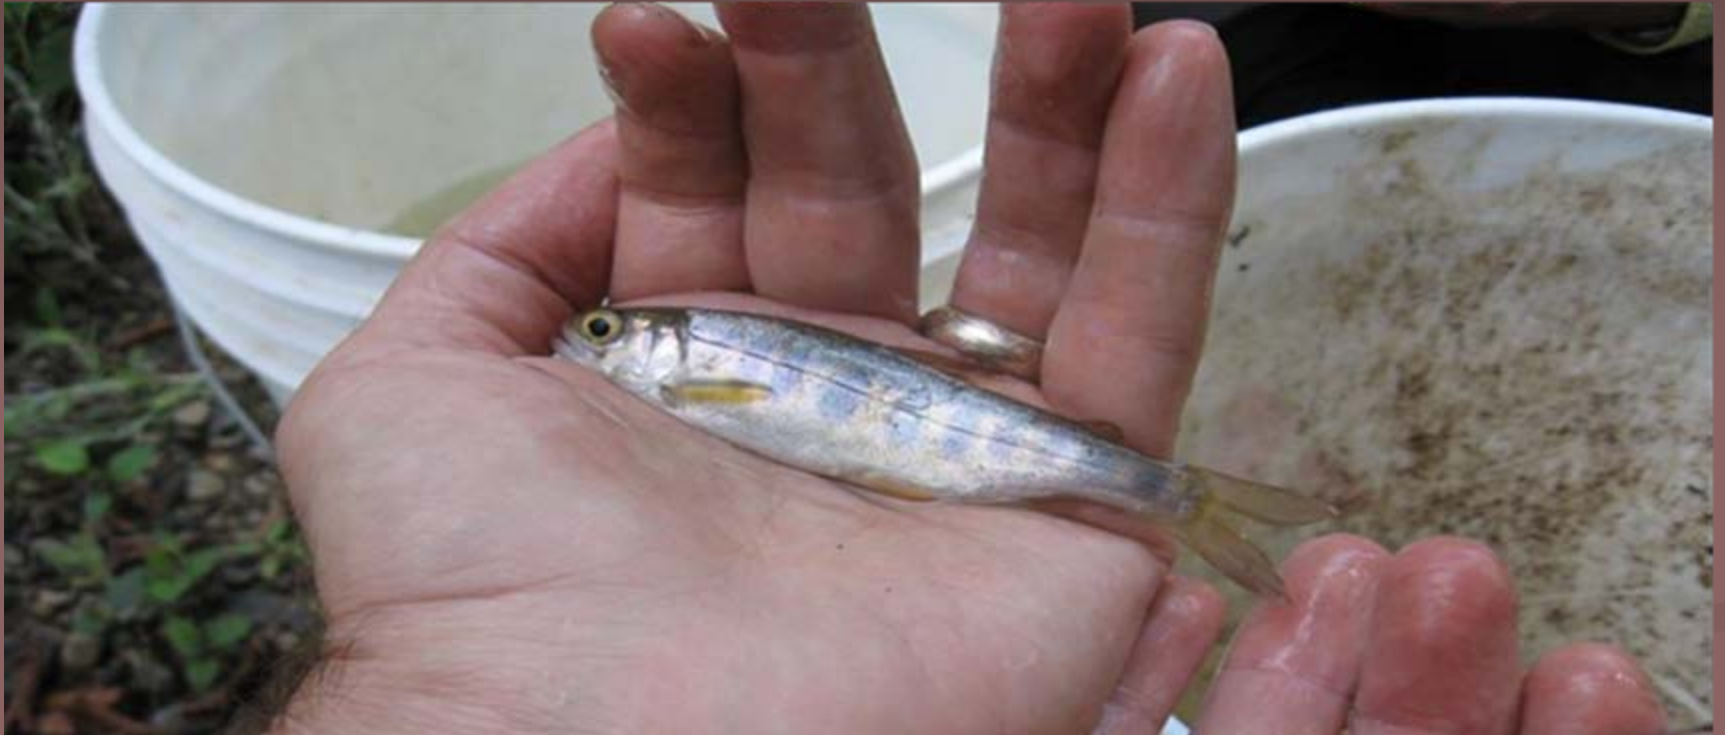
Walker Creek Juvenile Coho

- 80 Adults planted 2003/04
- 87 Adults planted 2004/05
- 40 Adults planted 2005/06
- 7 Coho redds 2006/07
- 57 Adults planted 2007/08
- 65 Juveniles observed 2004
- 176 Juveniles observed 2005
- 0 Juveniles observed 2006
- 193 Juveniles observed 2007
- 19 Juveniles observed 2008

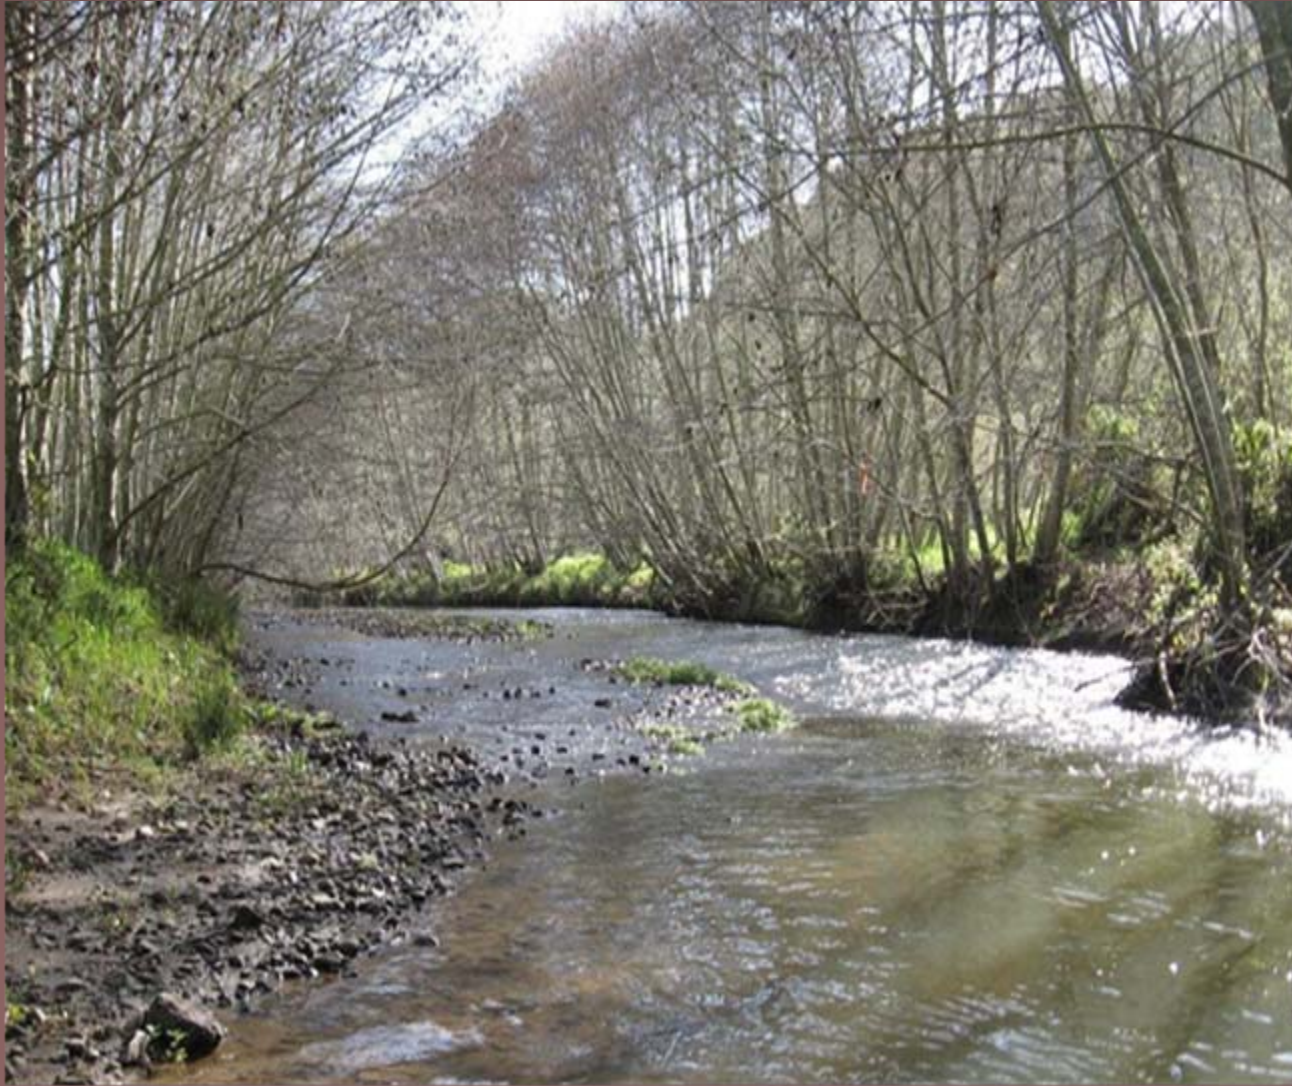
Walker Creek Coho Spawning

2006/07:

- 4 Adults
- 7 Redds

2007/08:

- 4 Redds

2008/09:

- 1 Redd

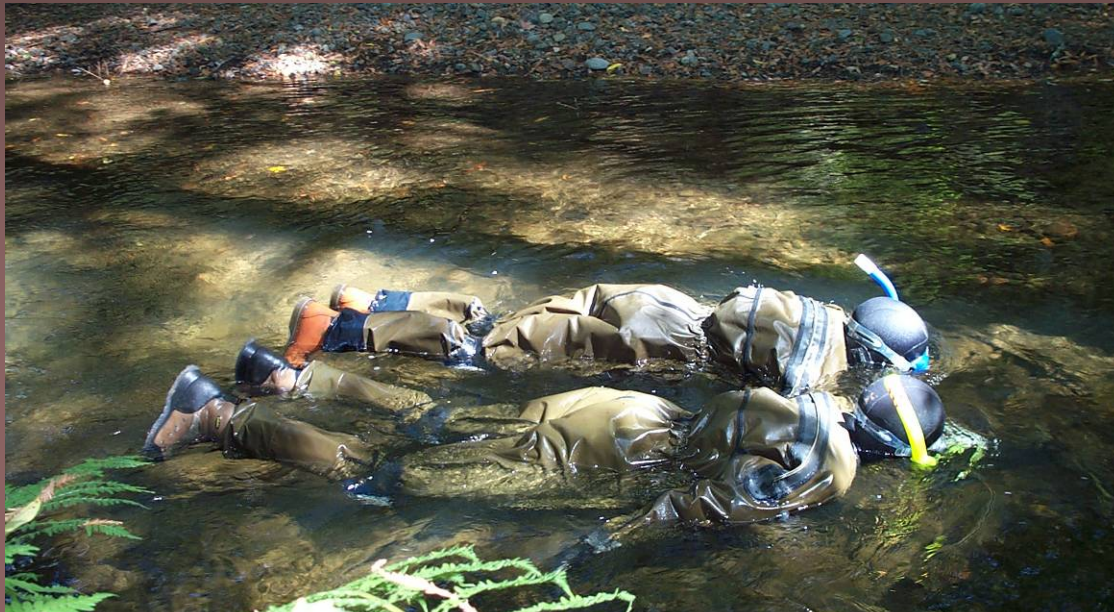
Snorkel Surveys

- Compare pre- and post-enhancement fish densities.
- Compare fish densities between enhancement and reference sites.
- Quantify coho and steelhead in enhancement and non-enhancement zones.

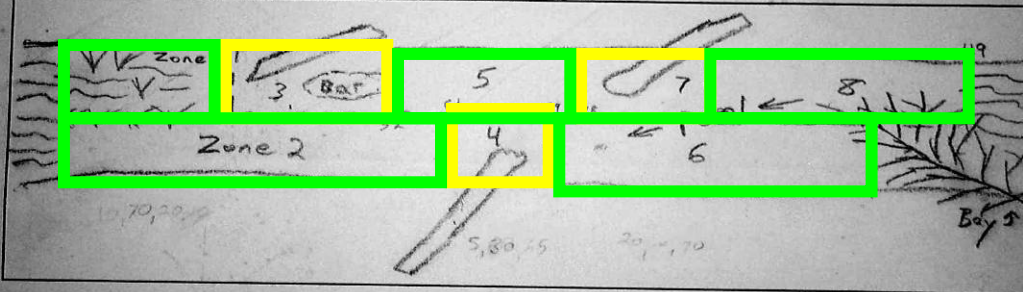
Sketch of creek showing woody debris structure(s) and snorkeling zones.

Describe zones to be snorkeled by each diver and record fish observed. Use unused lines for comments.

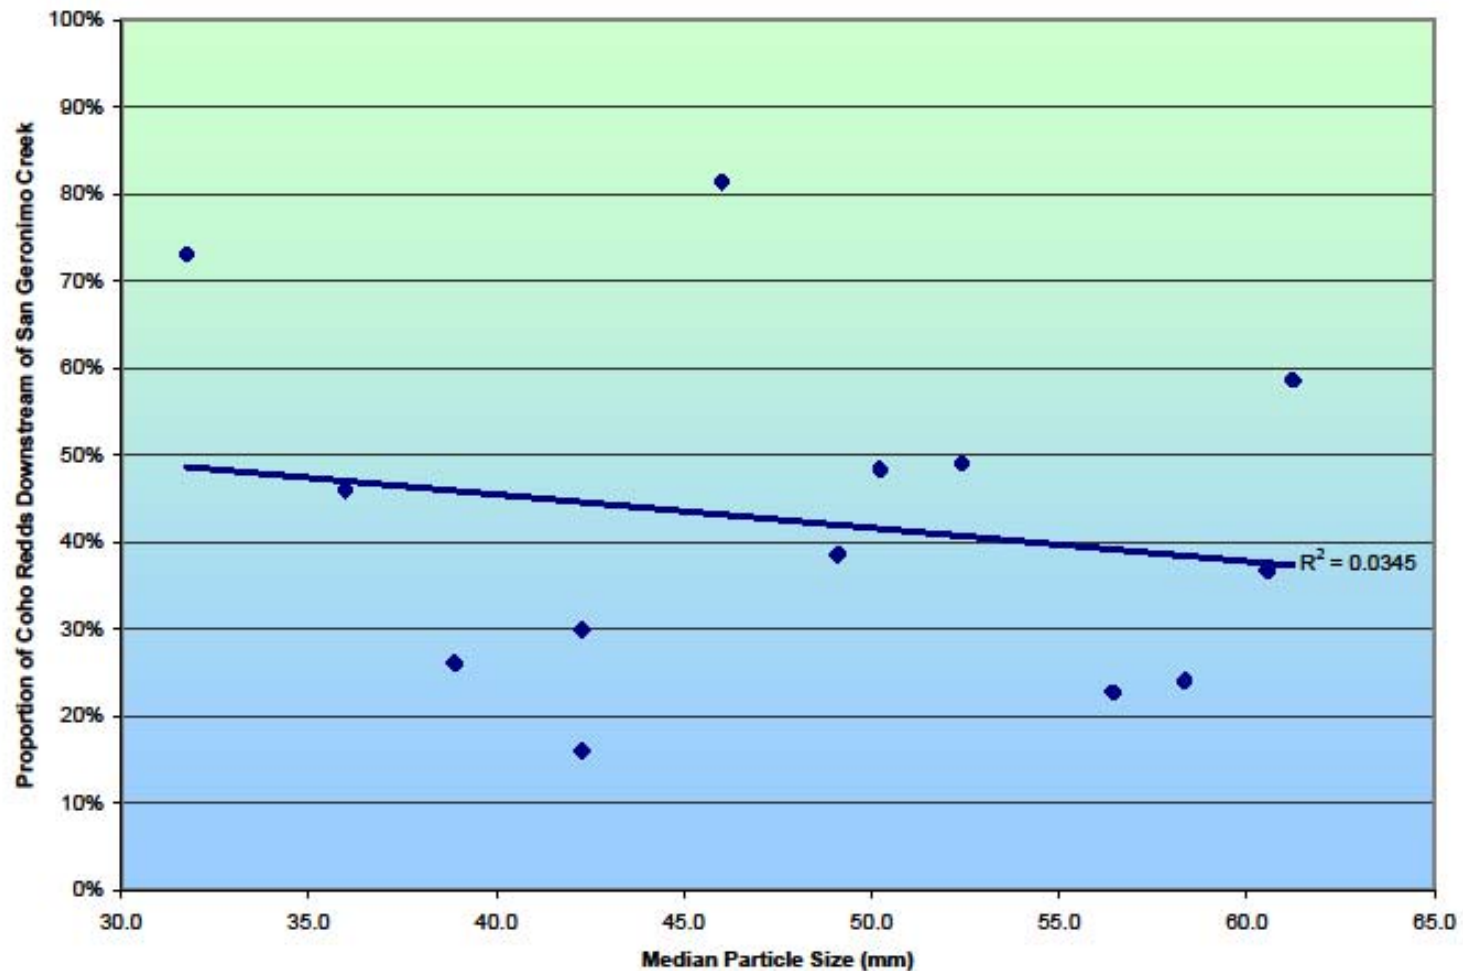
Figure 29. Median particle size in Lagunitas Creek riffles and the proportion of coho redds observed downstream of San Geronimo Creek, 1995-2008.

Salmon vs. Sediment Dynamics

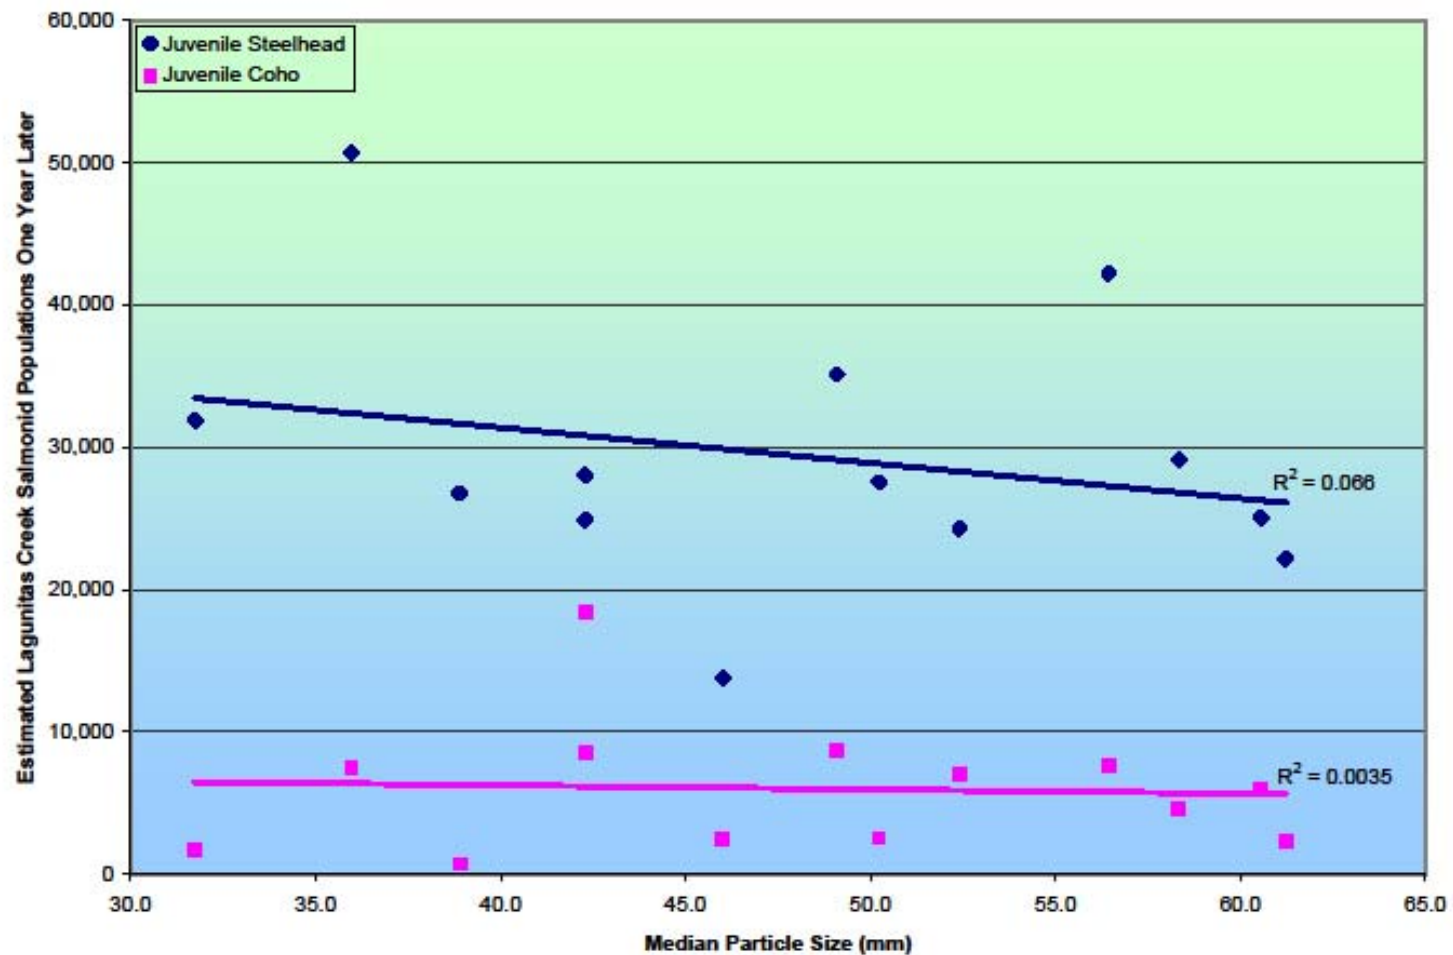
Figure 31. Median particle size in Lagunitas Creek riffles and juvenile salmonid populations one year later, 1996-2009.

Salmon vs. Sediment Dynamics

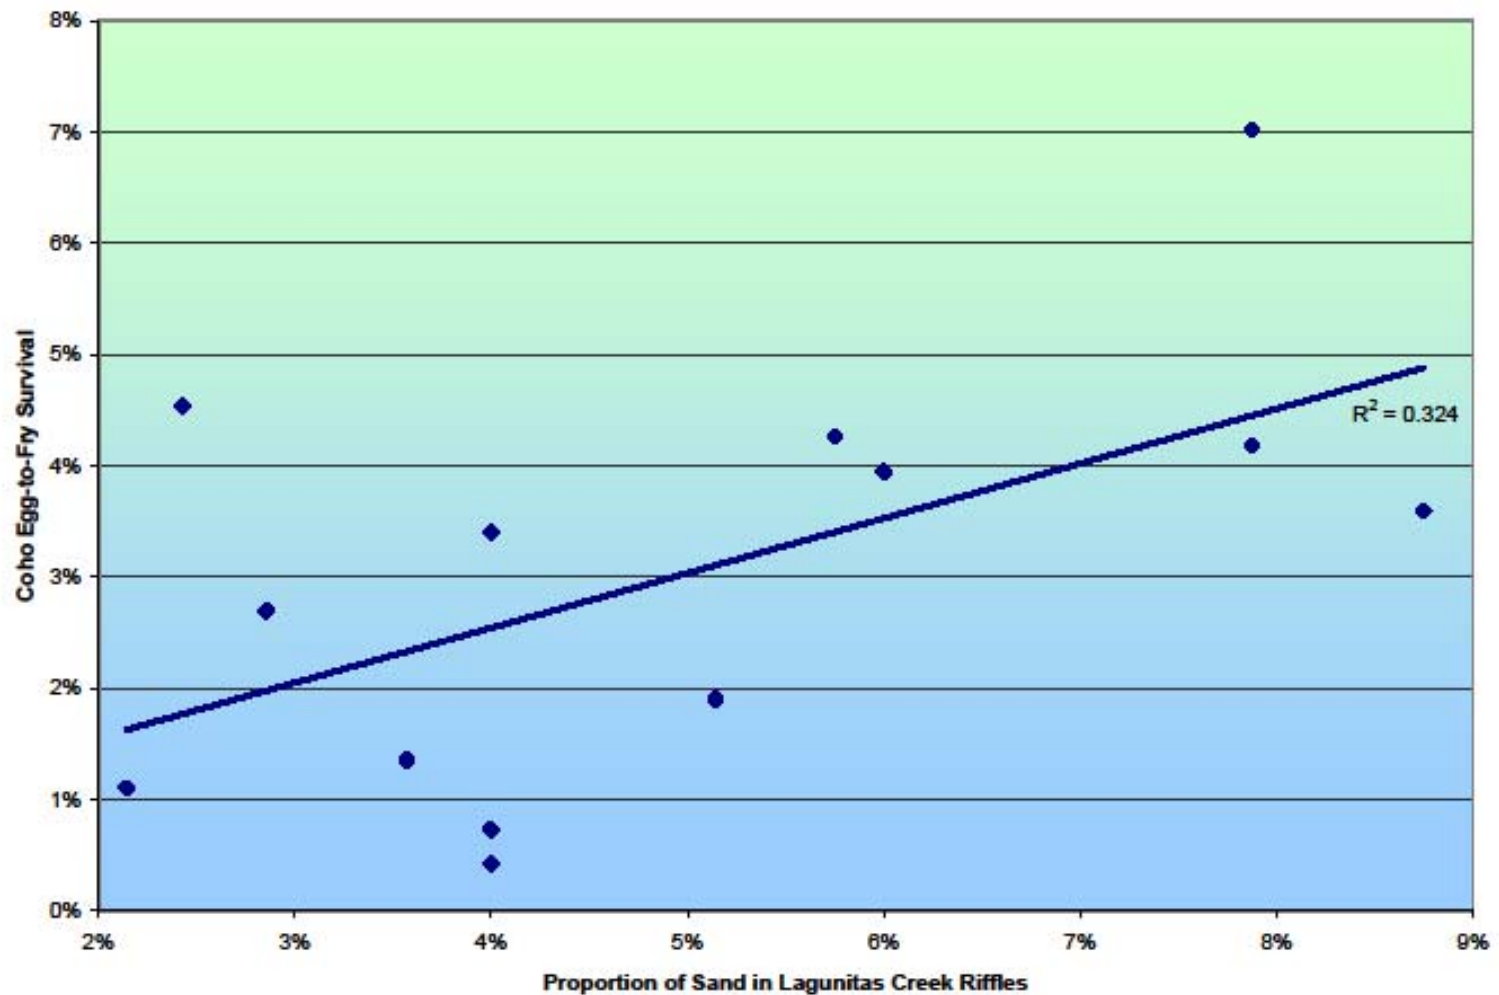
Figure 32. Proportion of sand in Lagunitas Creek riffles and the subsequent survival rate of coho eggs to fry, 1996-2009.

Salmon vs. Sediment Dynamics
