# Discussion of Post-fire runoff and Debris Flow Generation

Don Lindsay, CEG, GE

California Geological Survey

Quantifying the Runoff, Debris Flow, and Landslide Response to 2018 Carr Fire

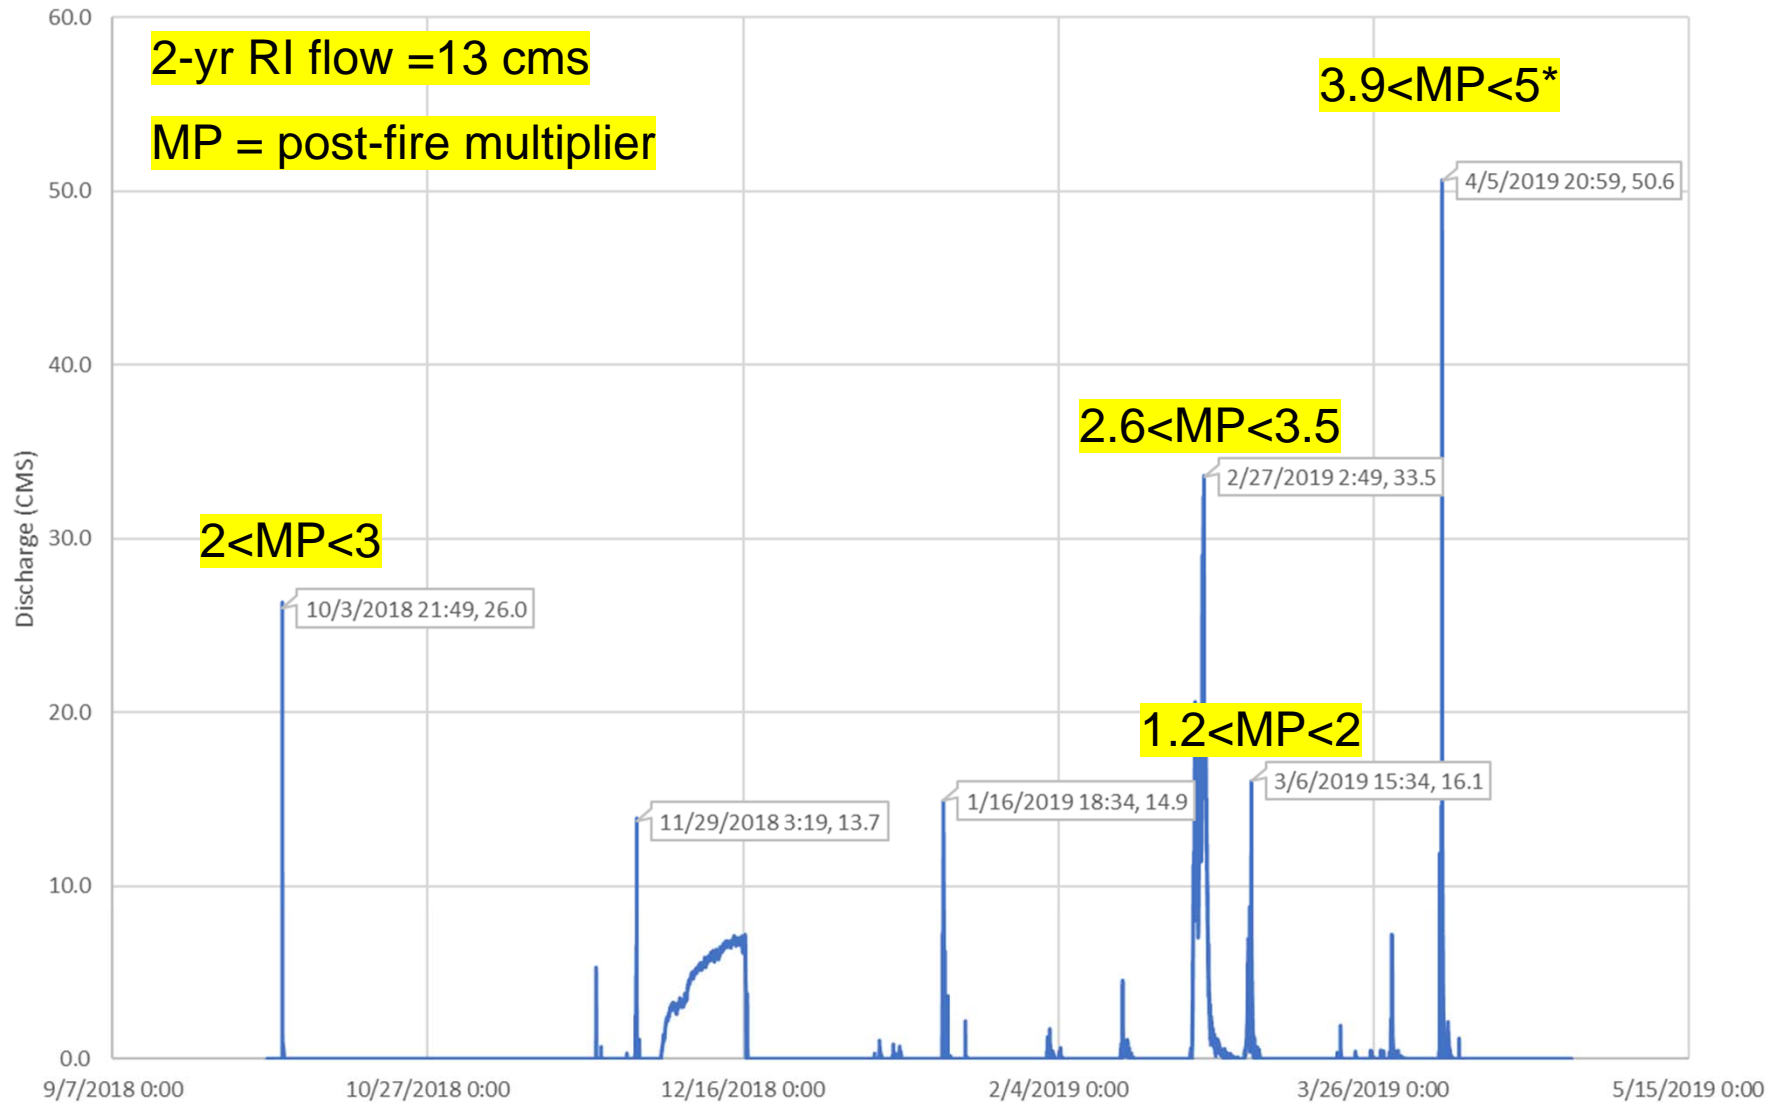
\* I30 rainfall on 4/5/19 was close to a 5-yr RI event, thus the MP based on a 5-yr flow could be as low as 2.2
