Butte Fire

CA AEU-024918

Post Fire Emergency Watershed Response Team

October 12, 2015

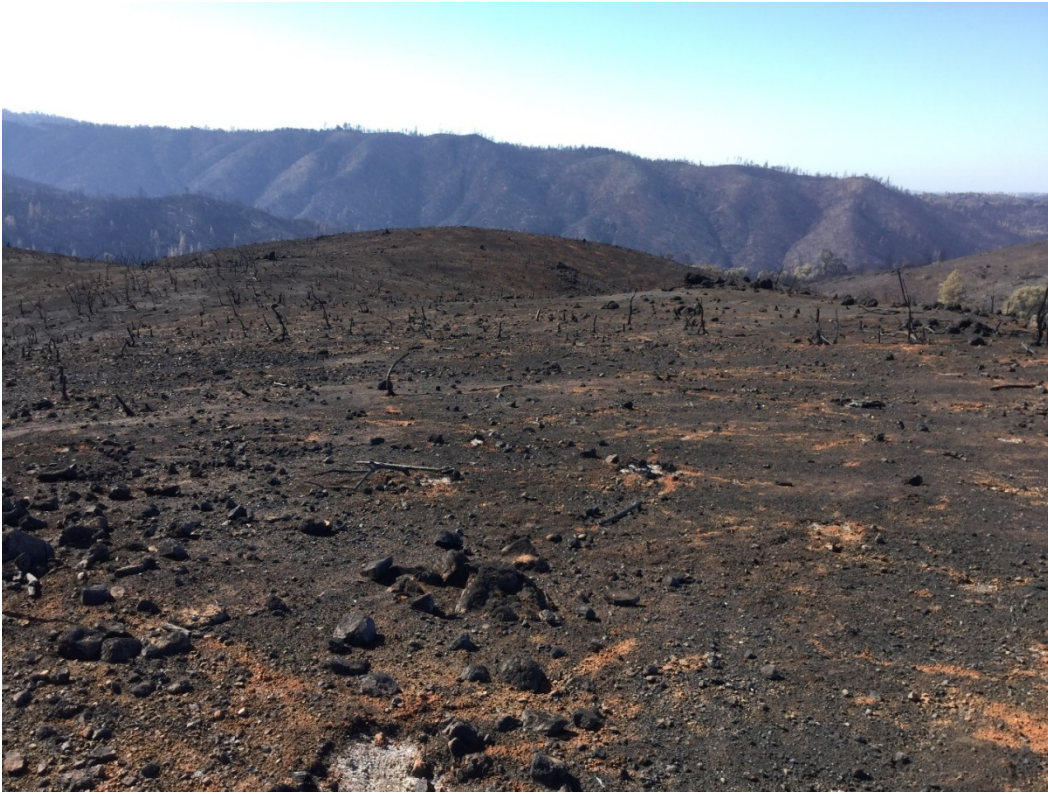
View southwest over the burned watersheds of Jesus Maria Creek, North Fork Calaveras River. In the foreground, manzanita was denuded by the fire and organic litter and duff exhibited high soil burn severity (ash and soil are moist from recent rainfall).

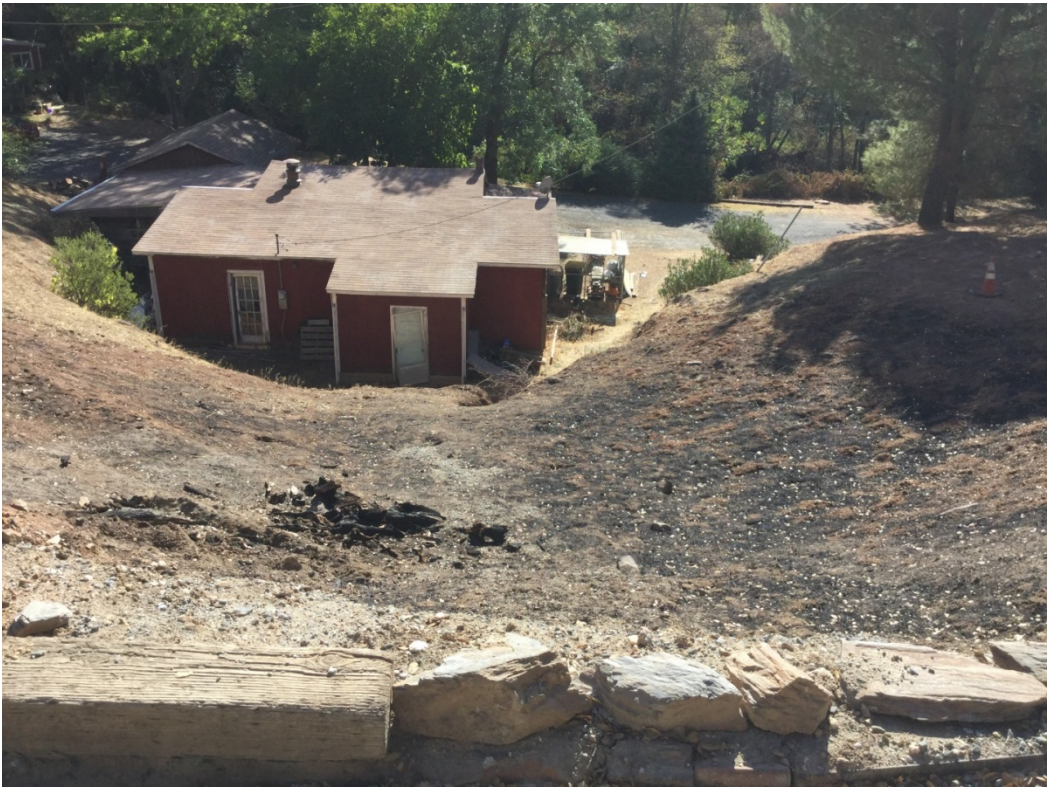
Residence in the drainage path of a small basin tributary to Murray Creek. The upstream side of the culvert is approximately half filled with sediment, the downstream side is buried in artificial fill. The basin upstream of the culvert experienced moderate-to-high soil burn severity.

Road System: Storm patrol of the stormwater drainage system (ditches, culverts, and bridges) should be conducted to ensure proper function. Ditch and culvert cleanouts may be necessary after each storm event, in addition to sediment removal from roadways. Culverts that have not been designed to the 100-year level should be replaced to increase the ability of the drainage facility to handle to probable volumes of storm runoff.

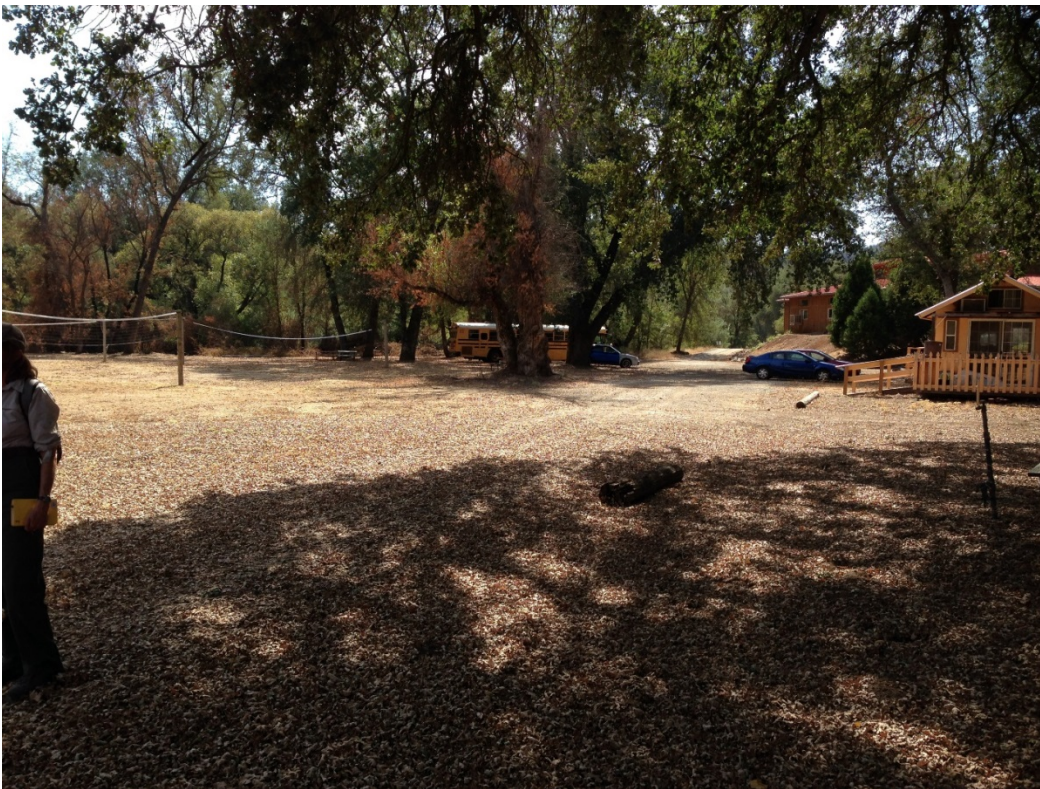
School bus parking lot at California Caverns. The floodplain adjacent to California Caverns is located at the confluence of McKinney Creek and Martin Gulch. Both of these watersheds experienced moderate-to-high soil burn severity.

It is recommended that a general public advisory be issued to landowners regarding elevated flooding and debris-laden runoff potential near rivers, streams and hillsides, including evacuation notices as necessary. Additionally, placement of transitional housing on low-lying ground susceptible to flooding and debris flows should be avoided.

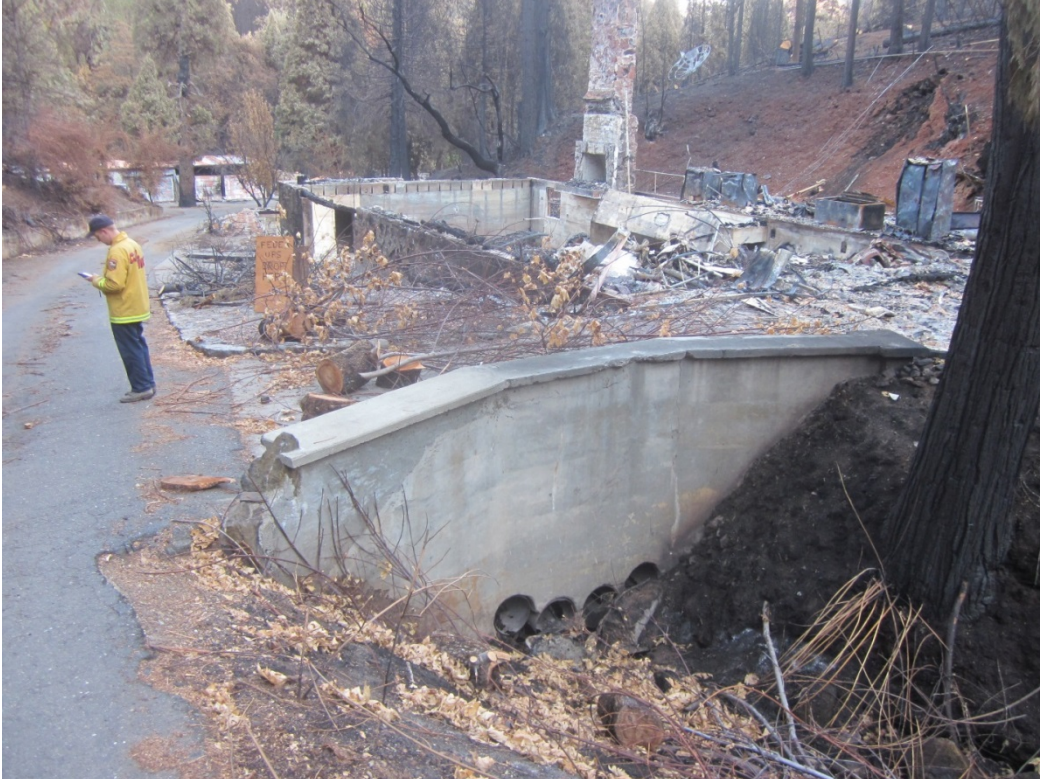
Burned residence constructed within a watercourse. Culverts constructed under the residence may experience increased flows, including sediment, woody debris and ash.

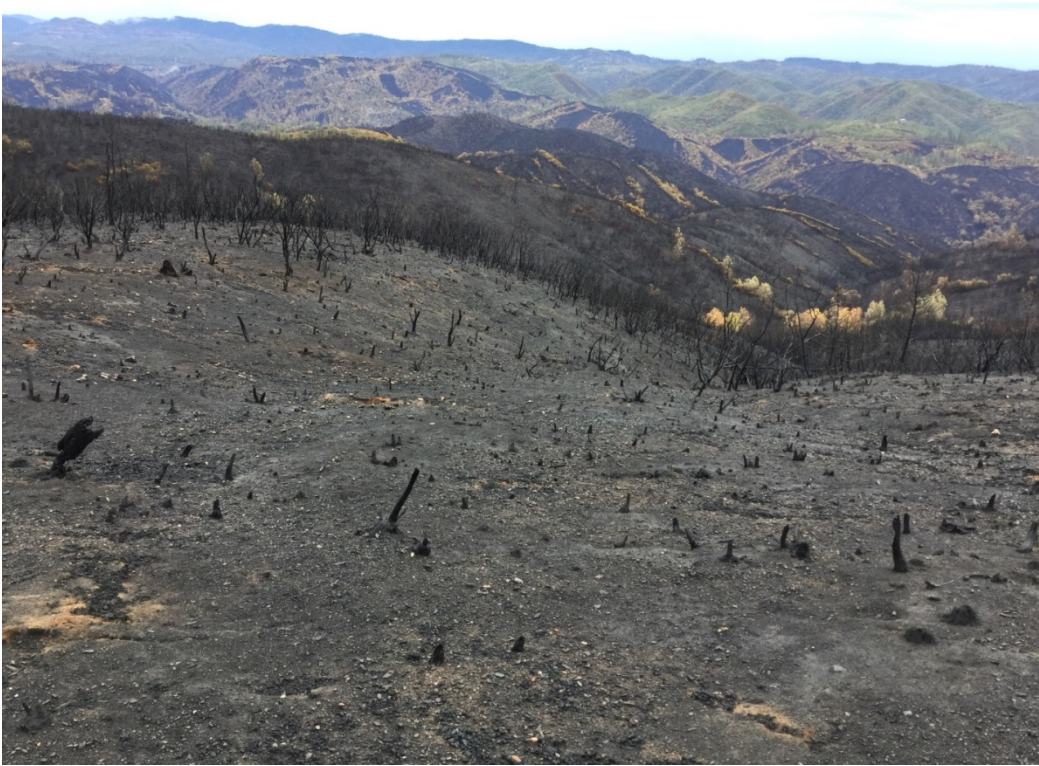
View southeast over the burned watersheds of O’Niel Creek and San Antonio Creek, South Fork Calaveras River. In the foreground, a relatively dense stand of manzanita was denuded by the fire and organic litter and duff exhibited high soil burn severity (ash and soil are moist from recent rainfall).
