Demonstration and Test Structures for Urban-Wildland Interface: Wildfire and Wood-Destroying Insects

Stephen L. Quarles, Frank C. Beall, and Vernard R. Lewis

Abstract

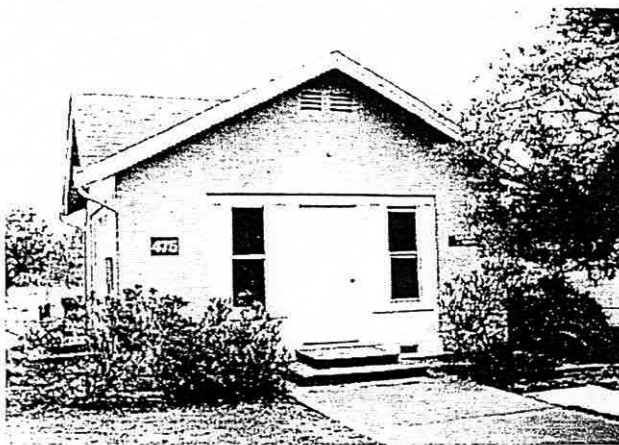
Figure 6. ~ The woodframe structure (Villa Termiti) built specifically as a test bed for efficacy trials involving detection devices, non-chemical and least-toxic management methods.

To simulate field conditions, a woodframe structure (named Villa Termiti) was built specifically as a test bed for efficacy trials involving detection devices, non-chemical and least-toxic management methods for drywood termites, as well as exterior soil sprays for foraging ants. The test bed has three levels (attic, drywall living space, and crawl space) and considerable useable space (20 by 20 ft. or 400 ft.²) (Fig. 6). Construction materials included Pacific Douglas-fir (*Pseudotsuga menziesii* (Mirb.) Franco var. *menziesii*) for stud walls, headers, and rafters, and foundation-grade redwood (*Sequoia sempervirens* (D. Don) Endl.) was used for

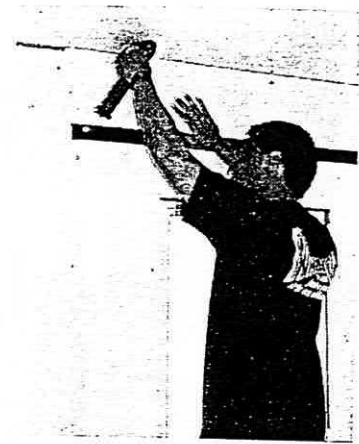
Figure 9. ~ Artificially infested boards containing termites were randomized and installed in the test bed in exposed locations and behind drywall using drywall screws.
